BELZONA RESTORATION OF HISTORIC FEDERAL BUILDING

Customer Location: Pensacola, Florida

Application: RPA-Roof Problem Areas

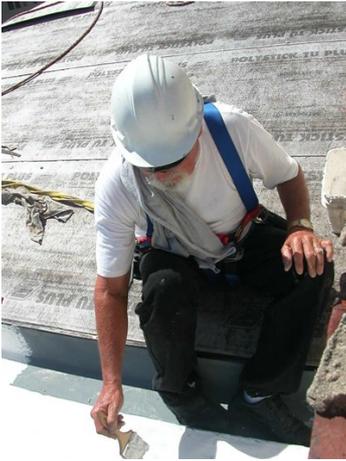
- * Belzona® 3111 being applied ,
- * Belzona initially applied to gutter seams ,
- * View of the finished gutter system coated with Belzona® 3111 ,
- * Another view of the finished gutter system coated with Belzona® 3111 ,

Application was carried out in accordance with Belzona System RPA-6. Power wire brushing and degreasing was carried out prior to application.
