# Belzona Stairway to Heaven

**Industry:** Buildings & Structures  
**Application:** FPA-Floor Problem Areas  
**Substrate:** Ceramic Tiles  
**Products:** \* Belzona 5321 (SG Laminate) ,  
\* Belzona 9221 (Surefoot Aggregate White) ,

**Customer Location:** Croatia, Zagreb  
**Application Date:** June 2018

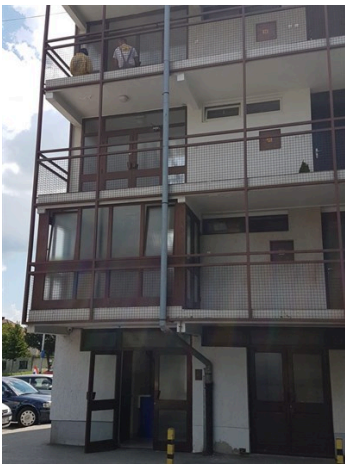
- \* 1. Block at flat of where the application was taking place ,
- \* 2. Previous cheap adhesive tape solution ,
- \* 3. Belzona 5321 being applied ,
- \* 4. Finished application ,

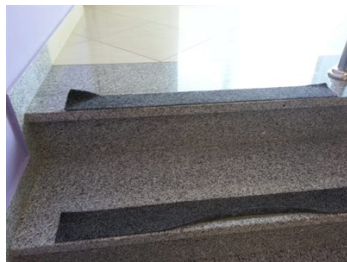
The customer had previously installed several types of cheap adhesive tapes which all lasted a very short time and didn't perform well. Since this was an indoor application and the distributor knew that the price would be an issue. One coat of Belzona 5231 with Belzona 9221 (Sure-foot Aggregate) incorporated was recommended. 2 packages of Belzona 5231 (Dark Grey, 4 liters each) and 5 packages of Belzona 9221 (2 kg each) were used.
