Belzona Stairway to Heaven

ID: 7962

Industry: Buildings & Structures
Application: FPA-Floor Problem Areas
Substrate: Ceramic Tiles
Products: * Belzona 5321 (SG Laminate) ,
* Belzona 9221 (Surefoot Aggregate White) ,

Customer Location: Croatia, Zagreb
Application Date: June 2018

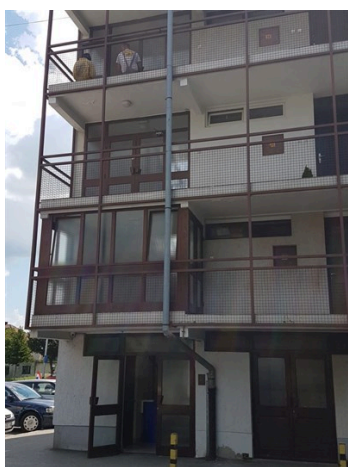
The application was a four story building with 32 flats and the stairway wasn't heated as it was located at the end of the building. The Ceramic tiles in the stairway got very slippery and in winter the water on the floor often freeze, creating a trip hazard.

- * 1. Block at flat of where the application was taking place ,
- * 2. Previous cheap adhesive tape solution ,
- * 3. Belzona 5321 being applied ,
- * 4. Finished application ,
