Belzona Stairway to Heaven

ID: 7962

Industry: Buildings & Structures
Application: FPA-Floor Problem Areas
Substrate: Ceramic Tiles
Products: * Belzona 5321 (SG Laminate) ,
* Belzona 9221 (Surefoot Aggregate White) ,

Customer Location: Croatia, Zagreb
Application Date: June 2018

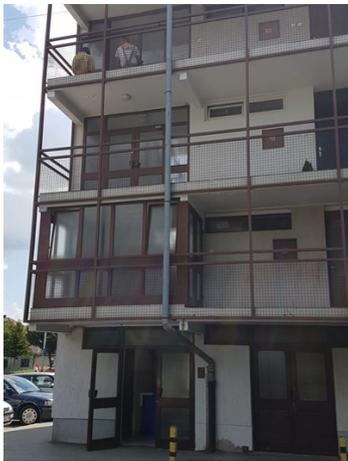
- * 1. Block at flat of where the application was taking place ,
- * 2. Previous cheap adhesive tape solution ,
- * 3. Belzona 5321 being applied ,
- * 4. Finished application ,

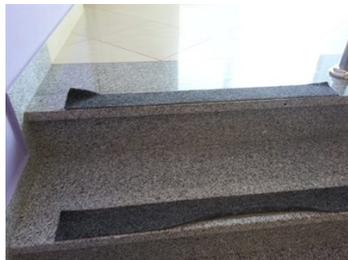
The customer had previously installed several types of cheap adhesive tapes which all lasted a very short time and didn't perform well. Since this was an indoor application and the distributor knew that the price would be an issue. One coat of Belzona 5321 with Belzona 9221 (Sure-foot Aggregate) incorporated was recommended. 2 packages of Belzona 5321 (Dark Grey, 4 liters each) and 5 packages of Belzona 9221 (2 kg each) were used.
