BELZONA CREATES POSITIVE GRIP ON RUBBER CLAD CONVEYOR DRIVE ROLL

ID: 7965

Industry: *Mining & Quarrying*
Application: *SHM-Solids Handling Machinery*

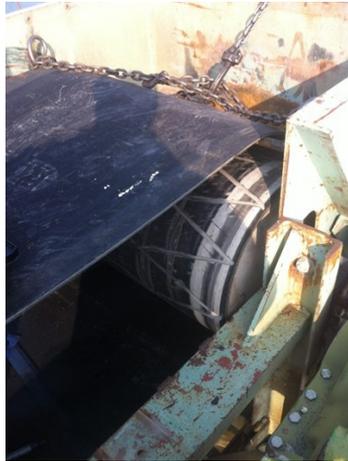
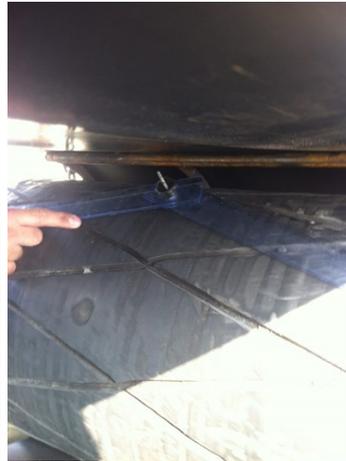
Photograph Descriptions

Worn rubber cladding was allowing belt slippage on a floating conveyor system used for transporting gravel. Whenever it happened on one of the rollers, the whole system would stop and it takes 30 minutes to restart it back to operating at full service. In rainy periods of the year this happens often and it is a significant loss of production time. Customer should also have spare rollers in stock ready for immediate installation.

- * 1. Floating conveyor systems used for transporting gravel ,
- * 2. Worn out rubber cladding ,
- * 3. Preparing for the installation of Belzona 2111 ,
- * 4. Fully applied system ,

Anti-slip chevron strips were applied directly onto an existing worn rubber lining of a conveyor drive roller. This was done without removing the lining and without dismantling the roller.

planned downtime of the plant. The conveyor belt was removed 10 cm away from the roller so that the roller could be rotated manually during the application, without touching the belt. Surface preparation was completed with a rotary wire brush and Belzona hand tools for the rubber. Next, chevron strips were marked with masking tape and the surface was conditioned with Belzona 2911. Finally, Belzona 2111 was brush applied and Belzona 9211 was incorporated into the material.
