BELZONA CREATES POSITIVE GRIP ON RUBBER CLAD CONVEYOR DRIVE ROLL

ID: 7965

Industry: Mining & Quarrying
Application: SHM-Solids Handling Machinery

Customer Location: Zagreb, Croatia
Application Date: April 2014

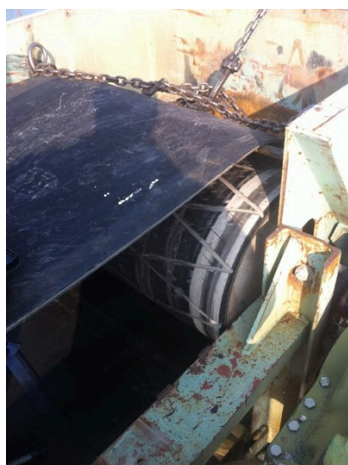
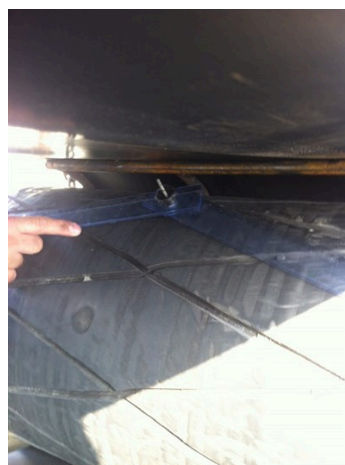
Photograph Descriptions

Worn rubber cladding was allowing belt slippage on a floating conveyor system used for transporting gravel. Whenever it happened on one of the rollers, the whole system would stop and it takes 30 minutes to restart it back to operating at full service. In rainy periods of the year this happens often and it is a significant loss of production time. Customer should also have spare rollers in stock ready for immediate installation.

- * 1. Floating conveyor systems used for transporting gravel ,
- * 2. Worn out rubber cladding ,
- * 3. Preparing for the installation of Belzona 2111 ,
- * 4. Fully applied system ,

Anti-slip chevron strips were applied directly onto an existing worn rubber lining of a conveyor drive roller. This was done without removing the lining and without dismantling the roller.

planned downtime of the plant. The conveyor belt was removed 10 cm away from the roller so that the roller could be rotated manually during the application, without touching the belt. Surface preparation was completed with a rotary wire brush and Belzona hand tools for the rubber. Next, chevron strips were marked with masking tape and the surface was conditioned with Belzona 2911. Finally, Belzona 2111 was brush applied and Belzona 9211 was incorporated into the material.
