Belzona protects large bund from chemical attack

ID: 7966

Customer Location: Spain
 Application Date: June 2017

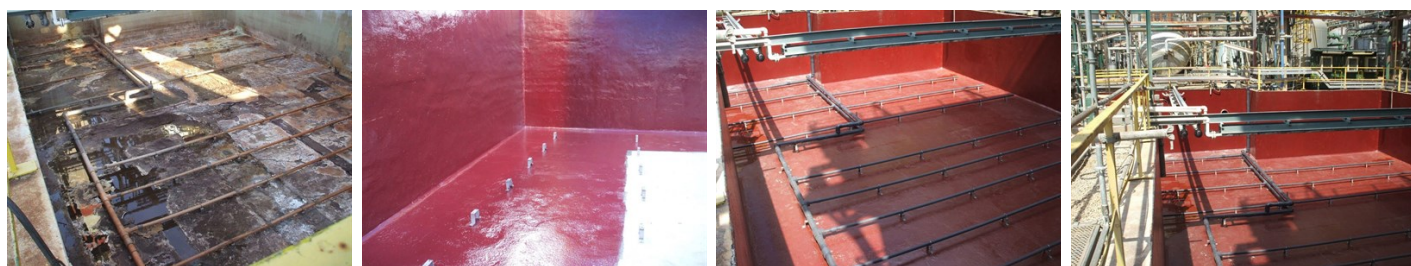
Photograph Descriptions

The aggressive chemicals have caused severe damage to the existing coating and the concrete beneath causing environmental concerns.

- * 1. Initial condition before repair ,
- * 2. Belzona coating applied ,
- * 3. After 1.5 years in service ,
- * 4. Second view after 1.5 years in service ,

The application was carried out in accordance with Belzona System Leaflet TCC-15. The concrete was first cleaned with high pressure water jetting to remove the existing coating and contamination from the substrate. The surface was then grit blasted using a metallic grit, before Belzona 4911 was applied to ensure excellent adhesion. Finally, a two coat system of Belzona 4341 was applied to form a protective barrier.

A previous coating has failed to last after a short time in service. The customer required a long lasting coating to prevent the possibility of degradation of the concrete, which could lead to spillages into the ground. The customer had previous experience with Belzona solutions for various applications including pumps, composite patches, composite pipe wraps and more - and so had confidence that Belzona could deliver a solution for this application. After 1.5 years in service, the area was revisited and found to be in excellent condition.
