BELZONA RECONSTRUCTS THE COVER AND FLANGE OF A HEAT EXCHANGER

ID: 7972

Application: HEX-Heat Exchangers

Customer Location: Petrochemical Plant, Gabon

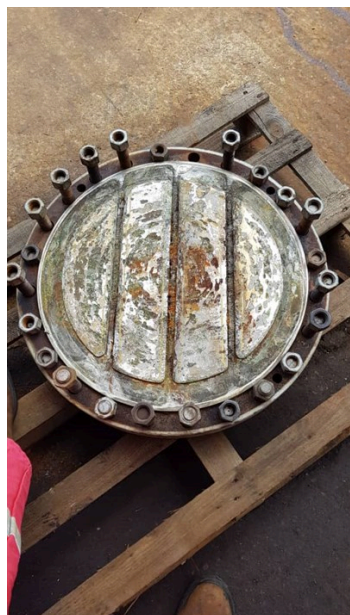
The flange and the cover of this exchanger were badly damaged by corrosion and needed to be rebuilt.

- * 1- Cover before application ,
- * 2- Flange before application ,
- * 3- Flange after application ,
- * 4- Cover after application ,

The substrate was first grit blasted to ensure a good mechanical bond with the product. Belzona 1111 was then used to rebuild the cover and the flange according to a modified version of Belzona System Leaflet HEX-02. Finally, the 2 parts of this equipment were machined back to the correct dimensions.
