Ahead of Turnaround Schedule Was Eased Up with Belzona Hot Wrap

ID: 7980

Customer Location: Mapthaput, Thailand
Application Date: 2018

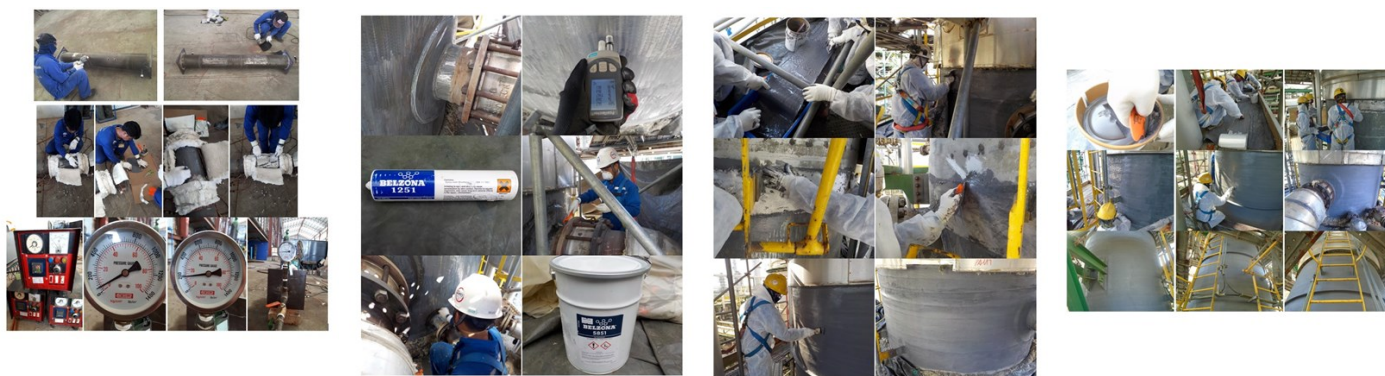
Photograph Descriptions

Internal corrosion of Process Water Stripper column caused lost wall thickness. Customer wanted to avoid unit shutdown for welding which would have meant total plant shutdown and the need to do it next year in major turnaround event, mid of 2020

- * 1. Mock Up Test ,
- * 2. Belzona 1251 Application ,
- * 3. Belzona 9371 Application ,
- * 4. Belzona 5851 Application ,

Due to the fact that we have to work on hot surface all the time, surface preparation by flap disc and pneumatic rotary grinding machine were allowed to use to remove all existing silicone base paint and most of inorganic ethyl zinc silicate. After that we used Belzona 1251 to smooth out weld seams and rim of nozzle reinforcement pads. Finally we applied two wraps (four layers) of Belzona 5851 together with Belzona 9371 around the target area Total application area 31 sq.m.
