# Coating Internal Surface of Cooling Water Pipeline

ID: 7981

**Customer Location:** Ratchaburi, Thailand  
**Application Date:** 2018

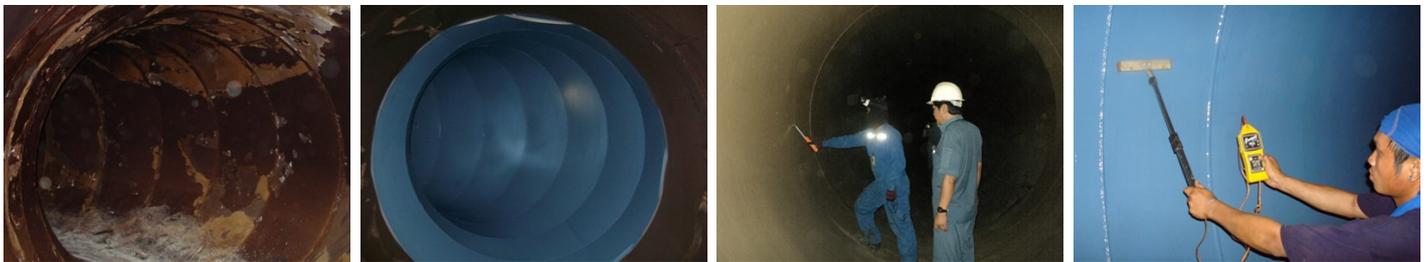
## Photograph Descriptions

The cooling water (CW) pipe is the main focus for coating application due to failure of a previous coal tar epoxy coating on the internal surface of the pipe. The coal tar epoxy suffered from low adhesion and subsequently suffered from major blistering and peeling after three years. The customer was keen to find a high quality coating for long lasting service.

- \* 1. Internal Corrosion ,
- \* 2. 2 coats of Belzona 1341 ,
- \* 3. 2 coats of Belzona 5811 ,
- \* 4. Spark tested Spark test of Belzona 1341 ,

Copper slag was used to blast the pipe to achieve a minimum profile of 75 microns and a surface cleanliness of SSPC-SP10/SA 2.5 for better adhesion. The surface profile was measured using TESTEX Tape. Salt contamination was measured to having less than 4 µg/cm<sup>2</sup>. Two layers of Belzona 5811 was applied at a total thickness of 400 microns in laminar flow areas and two layers of Belzona 1341 at a total thickness of 400 microns in turbulent flow areas. After fully cured, the dry film thickness was checked and monitored for pinholes.
