Belzona Gives New Life to Fan Blades

ID: 7982

Industry: Chemical & Petrochemical
Application: FBC-Fans, Blowers and Compressors

Customer Location: Rayong, Thailand
Application Date: 2018

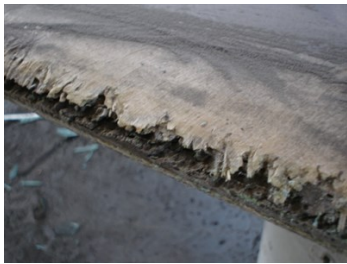
Deposit, erosion and mechanical damage of FRP fan blades for cooling tower were observed during turnaround period

* Lead Edge Damage Surface Preparation using Power tools application of Belzona 5111 Application of SWII ,
