Belzona Solution for Corroded Riser Casing

Offshore riser casing required a solution to extend service life

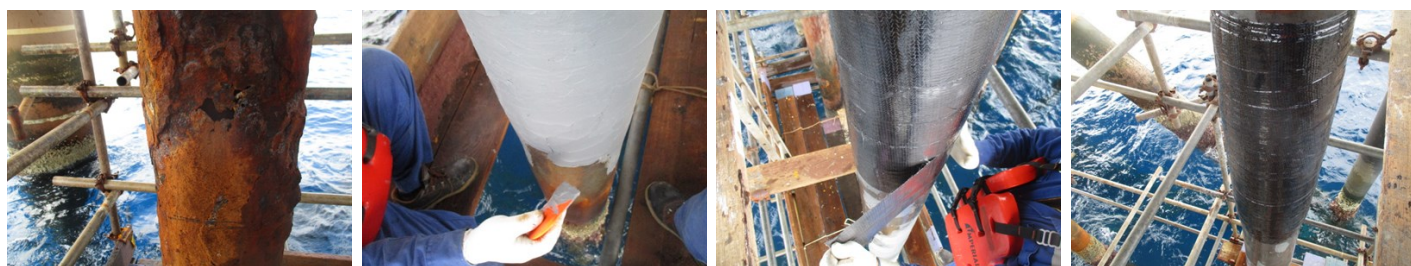
Photograph Descriptions

Leaked and severe corroded surfaces were observed on splash zone of riser casing.

- * 1. Corroded Riser Casing ,
- * 2. Rebuilding with Belzona 1111 ,
- * 3. Superwrap 2 Application ,
- * 4. Completed Application ,

Repair parameters, repair thickness, number of wrap and wrapping length have been calculated from operating condition of the pipe which are provided by customer. Surface has been prepared with garnet grit to achieved SA 2 1/2 level of cleanliness and roughness more than 75 microns. Leaked or through wall defects were stopped by Belzona 9611 then rebuilt corroded surfaces with Belzona 1111 then SuperWrap II repair system was applied by using Belzona 1982 SuperWrap II Resin with Belzona 9381 reinforcing fiber.
