# Belzona repairs a water slide in an amusement park

ID: 7985

Expansion joints on a water slide

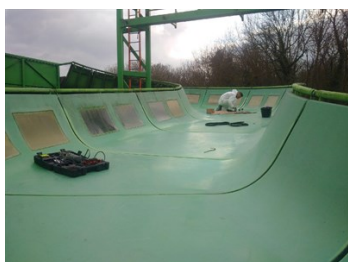
The expansion joints were badly damaged by the rubber rings used on the slide. This was causing water infiltration in the little tunnel underneath the slide where customers can walk.

- \* 1- Overview of the slide ,
- \* 2- Previous joints removed ,
- \* 3- Application of the elastomers ,
- \* 4- Zoom on the finished repair ,
