Belzona repairs a raw mill in a cement industry

ID: 7986

Industry: Mining & Quarrying
Application: SHM-Solids Handling Machinery

Customer Location: Ireland
Application Date: 2014

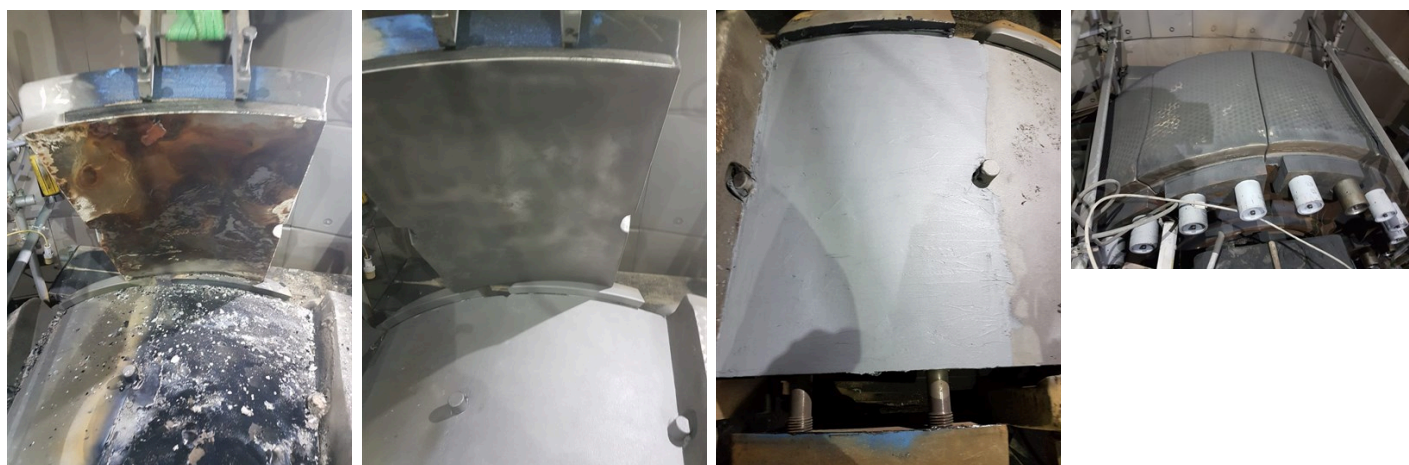
Photograph Descriptions

There are three rollers per mill and there are 12 wear plates (1200kg each) per roller. The clamps are fixed with 4 large bolts. There was play between the wear plate and the roller and the bolts and clamps were failing, leading to a forced stoppage of the mill.

- * 1- Before application ,
- * 2- After surface preparation ,
- * 3- After application of Belzona 1111 ,
- * 4- Final application ,

The application was done in accordance with Belzona System Leaflet SHM-8. Two wear plates were removed from the roller at a time and the area on the roller was grit blasted. The back of the new wear plate was also grit blasted and Belzona 1111 was applied to the roller in a layer of approximately 2cm thick in the position corresponding to one wear plate. The wear plate was then fitted onto the wet Belzona 1111 to create a perfect seat. The process was repeated until 12 wear plates had been installed.
