# Graphite Heat Exchanger restored with Belzona

Industry: Fluid Flow  
Application: HEX-Heat Exchangers  
Substrate: Graphite  
Products: \* Belzona 1391T,

Customer Location: Huelva - Spain  
Application Date: June 2018

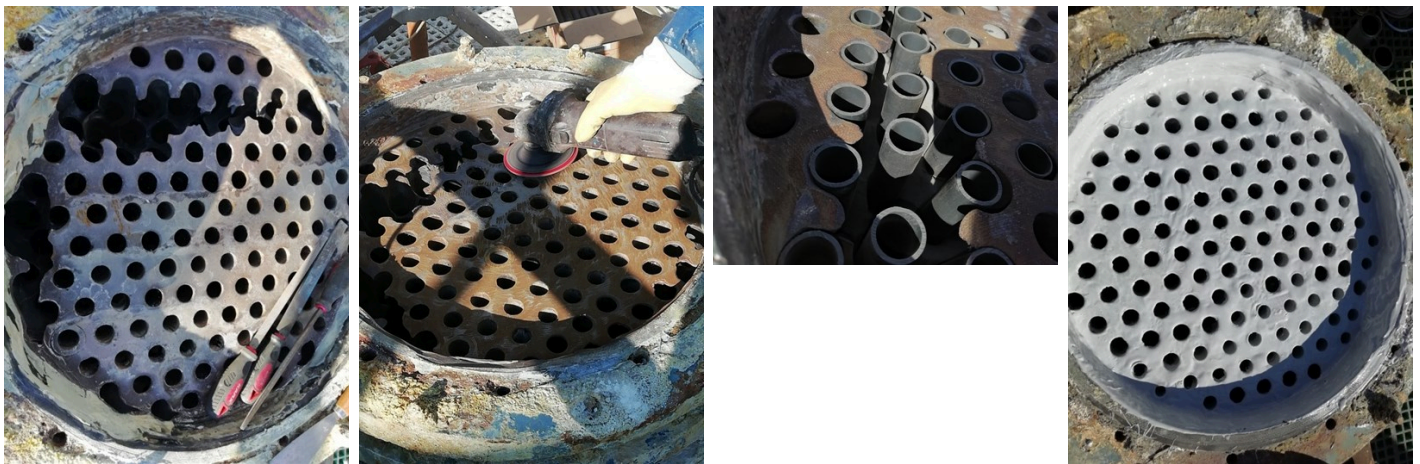
## Photograph Descriptions

*The tube sheet and some of the tubes have been severely damaged due to a combination of chemical and erosive attack. The loss of material causes a reduction in the thermal efficiency of the heat exchanger. Replacement is an expensive option.*

\* 1. Damaged Heat Exchanger Tube Sheet 2. Surface Preparation with mechanical grinder 3. PVC pipes in place 4. Completed repair ,

At a facility producing sulfuric acid from copper production by products. A heat exchanger with a graphite tube sheet, operating at temperatures up to 75°C carrying dilute sulfuric acid, chlorides, and entrained solids.

The surface was prepared using a mechanical grinder to remove contamination, getting back to clean & strong graphite, and achieving a rough surface. PVC tubes were inserted to form a mold around which the Belzona material can be poured, to restore the tube sheet back to it's original surface. Belzona 1391T was poured into the damaged areas, restoring the surface dimensions, and used to coat the entire surface, protecting from further damage. The application was carried out in accordance with a modified version of Belzona System Leaflet HEX-01 and HEX-03.

As the substrate was graphite, welding techniques to restore the surface were not possible. Replacing the equipment also carries a long lead time and a high cost. Cold applied Belzona materials were perfectly suited to restore the substrate back to it's original profile. Belzona 1391T has the high performance capabilities to resist the service conditions.
