# Seawater filter inlet area restored with Belzona

ID: 7988

Customer Location: *Spain*  
Application Date: *April 2018*

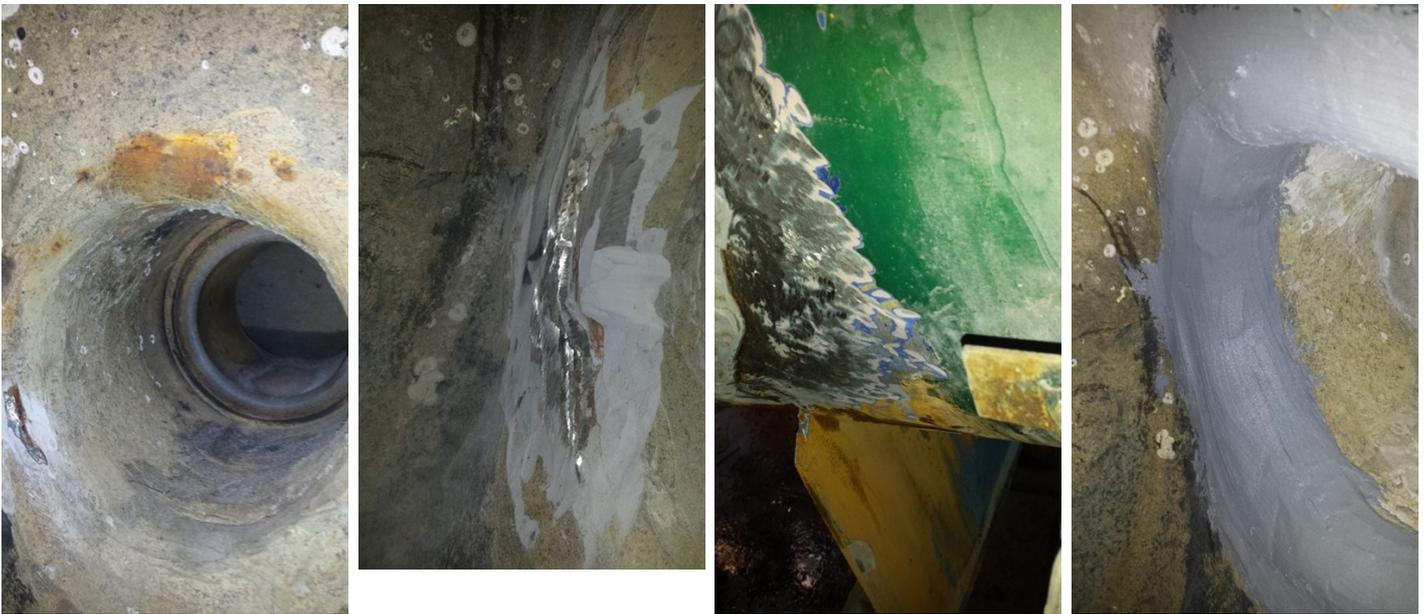
*The area connecting the inlet area to the main section of the seawater filter is suffering from corrosion due to the presence of salts. In one of the defect areas, the damage has become through wall and started to leak. This puts additional strain on the seawater pumps to maintain the pressure of flow rate.*

- \* 1. Corrosion on rim of inlet area ,
- \* 2. Through wall defect area prepared ,
- \* 3. Surface preparation on external surface ,
- \* 4. Completed repair ,

The seawater filter was taken out of service and drained. The surface was prepared using a mechanical grinder to both the internal and external surface. Belzona 1161 was used to cover the defects around the entire circumference of the inlet area. Where there was a through wall defect, Belzona 9341 was incorporated into the repair to add strength. The application was carried out in accordance with Belzona System Leaflet VPF-11.

Due to the limited access to the area, blasting equipment could not be brought into the area to prepare the surface. Additionally, the area was sheltered and away from sunlight, meaning it would take time for the substrate to become fully dry even after draining. It was therefore necessary to use Belzona 1161, as it can be applied to wet surfaces and achieves strong adhesion to surfaces prepared with a mechanical grinder. This helped to reduce the downtime of the equipment.
