# Belzona Floor Repairs at Food Manufacturer

Customer Location: Food Manufacturer in Northamptonshire, UK

Application: FPA-Floor Problem Areas

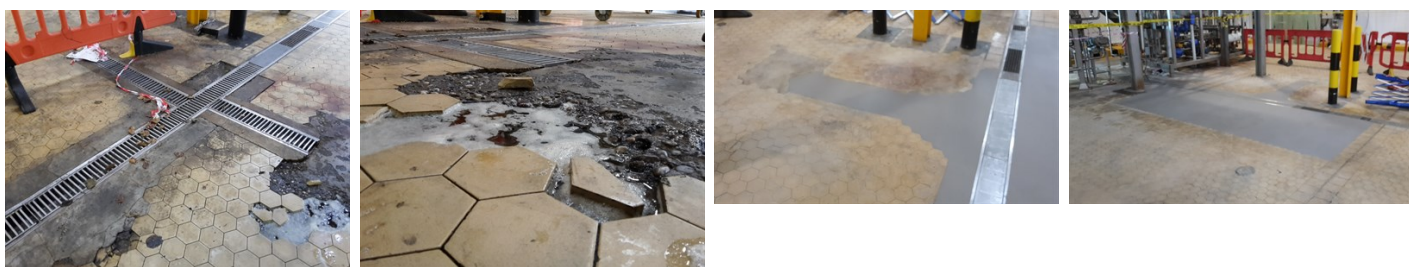
The customer had issues with the flooring where the tiles had started to lift and detach from the concrete substrate in a number of areas. The concrete was damp, wet and spalling in several areas.

- \* 1. Damaged concrete around drainage area ,
- \* 2. Extent of damage to floor with tiles removed ,
- \* 3. Belzona 4131 used to repair floor ,
- \* 4. Completed application ,

The area was cordoned off and the tiles removed to expose the concrete substrate. The surface was prepared using power tools to remove the loose concrete, tiles and to clean the corroded reinforcement. Belzona 4911 was applied prior to the application of Belzona 4131 using normal screeding techniques. A metal straight edge was then used to achieve a uniform thickness. Application was carried out in accordance with Belzona Know-How System Leaflet FPA-1.
