LANDING CRAFT WATER JET NOZZLES PROTECTED BY BELZONA

ID: 7995

Industry: *Marine*
Application: *SOS-Ships and Offshore Structures*

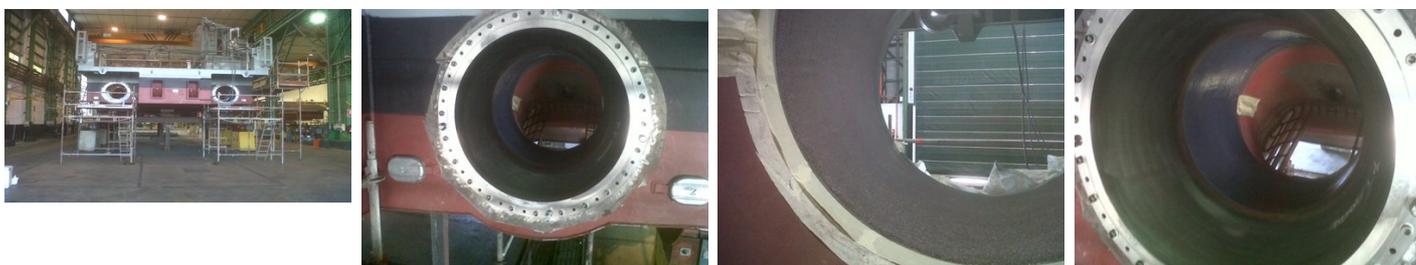
Photograph Descriptions

High flow rate, salt from sea water, and entrained solids cause accelerated wear of the water jet nozzles, therefore a protective system was required.

- * 1. View of the vessel hull ,
- * 2. Surface prepared, and Belzona 1321 (Ceramic S-Metal) applied ,
- * 3. Belzona 1812 (Ceramic Carbide FP) applied ,
- * 4. Completed Application ,

The stainless steel nozzles were machined to leave a rough profile to maximise the adhesion of the Belzona materials. Where the nozzles connect with the hull, grit blasting was carried out to achieve a white metal finish in accordance with Swedish Standard SA 3. Belzona 1321 (Ceramic S-Metal) was applied to the surface entire surface by brush. Belzona 1812 (Ceramic Carbide FP) was applied in the areas subject to high impact and abrasion. A final layer of Belzona 1321 was applied over the entire area to leave a smooth surface. The application was carried out in accordance with a modified version of Belzona System Leaflet SOS-02.
