Corrosion protection on filter chamber protected with Belzona

ID: 7999

Cement plant filter chamber

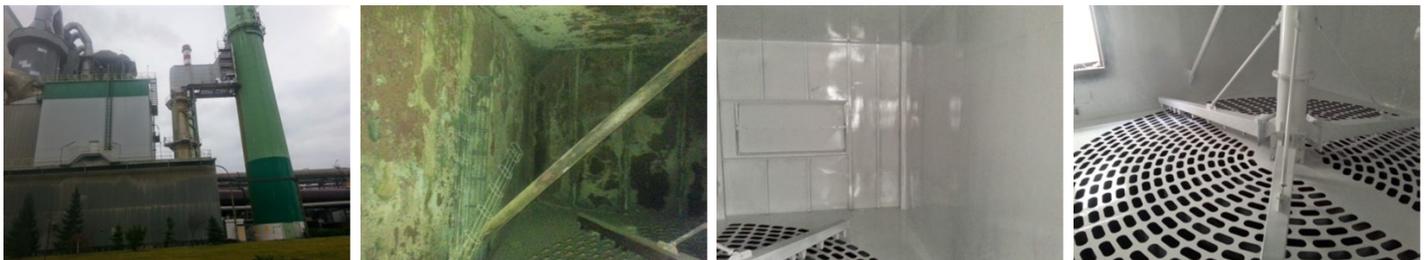
Photograph Descriptions

Hot gases had led to corrosion on internal surface of filter chamber. The rough surface caused by corrosion allowed a build up of dust on surface.

- * 1 - The filter house ,
- * 2 - Corrosion inside filter ,
- * 3 - The completed job ,
- * 4 - The completed job ,

After grit blasting the steel to clean the surface and generate a surface profile , the coating was applied in accordance with Belzona system leaflet WPA_2

The coating now provides long term corrosion protection , and as a result also prevents the buildup of dust within the filter , thereby simplifying cleaning procedures.
