BELZONA PROVIDES FAST PROTECTION OF SEA WATER FILTER

Industry: Oil & Gas
Application: TCC-Tanks and Chemical Containment Areas
Substrate: Carbon steel
Products: * Belzona® 1111 (Super Metal) ,
* Belzona® 1341 (Supermetalgilde) ,

Customer Location: Offshore Oil Production Company
Application Date: February 1997

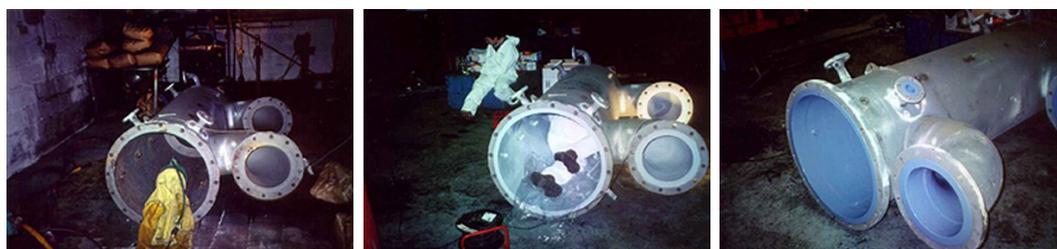
Photograph Descriptions

Previous lining failed very quickly and vessel corroded through. Spare unit did not fit, therefore, a fast turn-around was required.

- * Strainer body being prepared for coating after weld repairs to crevice corrosion on flange faces. ,
- * Application underway. ,
- * Completed application. Note coating taken across raised flange faces to eliminate further crevice corrosion. ,

Application was carried out in accordance with Belzona® Know-How Leaflets TCC-3 and VPF-13. Belzona® 1111 was used to smooth all welds before coating with 3 coat Belzona® 1341 System which was formed onto flange faces.
