Belzona Saves A Ruptured Effluent Tank

ID: 8000

Customer Location: Food Production Facility, UK
Application Date: October 2018

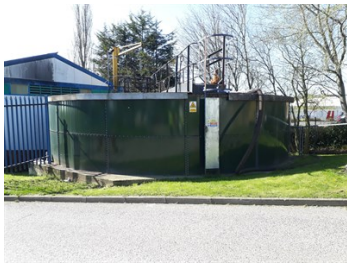
- * 1. Effluent treatment tank ,
- * 2. Extent of the leaks ,
- * 3. Plates bonded over repaired areas ,
- * 4. Sealed leaks around the base of tank ,

Leaking effluent treatment tank.

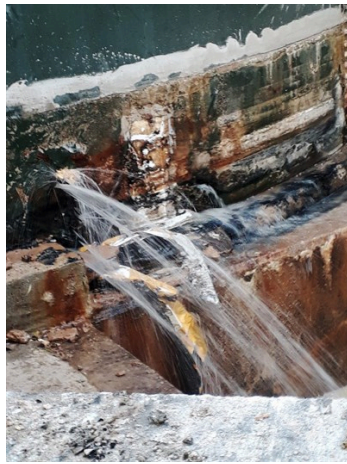
Corroded and through-wall defects on effluent tank created leaks in the system.

The leaks were plugged with wooden wedges to stem the flow. The areas around the leaks were then repaired with Belzona 9611 (ES-Metal). When the area was sealed, the wooden wedges were cut flush with the tank wall. They then bonded over the entire failed areas with Belzona 1111. Finally, when the Belzona 1111 had cured a bolt was screwed in, sealing the leaks. Belzona 1111 was also applied in a 75mm band around the base of the tank, incorporating reinforcing sheets, to seal the multiple leaks around the base. This was completed in accordance with Belzona system leaflet TCC-01.
