Belzona Saves A Ruptured Effluent Tank

ID: 8000

Industry: Water / Wastewater
Application: TCC-Tanks and Chemical Containment Areas

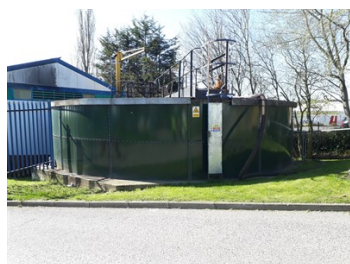
Corroded and through-wall defects on effluent tank created leaks in the system.

- * 1. Effluent treatment tank ,
- * 2. Extent of the leaks ,
- * 3. Plates bonded over repaired areas ,
- * 4. Sealed leaks around the base of tank ,

The leaks were plugged with wooden wedges to stem the flow. The areas around the leaks were then repaired with Belzona 9611 (ES-Metal). When the area was sealed, the wooden wedges were cut flush with the tank wall. They then bonded over the entire failed areas with Belzona 1111. Finally, when the Belzona 1111 had cured a bolt was screwed in, sealing the leaks. Belzona 1111 was also applied in a 75mm band around the base of the tank, incorporating reinforcing sheets, to seal the multiple leaks around the base. This was completed in accordance with Belzona system leaflet TCC-01.
