Belzona Repairs and Protects a Concrete Clarifier

ID: 8017

Industry: Water / Wastewater
 Application: FPA-Floor Problem Areas
 Substrate: Concrete
 Products: Belzona 4911 (TX Conditioner),
 Belzona 4131 (Magma-Screed),

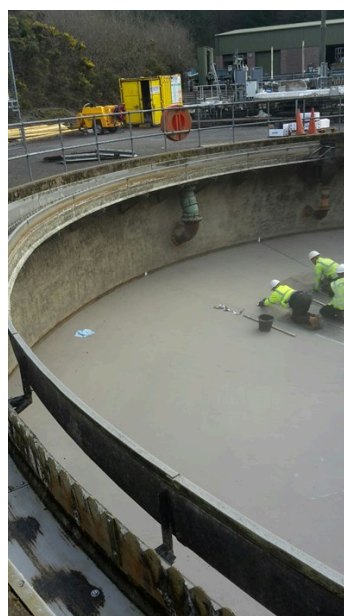
Placing screed rails

Belzona 4131 application by float

Application underway

The application was carried out in accordance with a modified version of Belzona KNow-How System Leaflet FPA-1. The concrete was first power washed and prepared mechanically. The clarifier was marked out into sections. Each section was then conditioned with Belzona 4911 and then 6mm of Belzona 4131 applied.

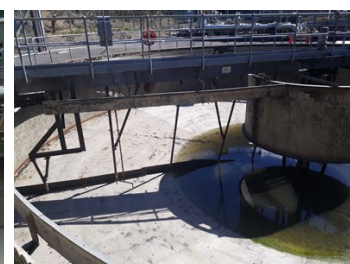
The tank drained one year on

mechanical strength and chemical resistance the original concrete. The tank was drained for a shutdown in May 2019 & found to be in a perfect condition.
