Belzona Restores Internal Tank Wall against Corrosion

ID: 8032

Industry: Oil & Gas
Application: TCC-Tanks and Chemical Containment Areas

Repair of a steel tank (980 m3) used to store a mixture of salt water and oil.

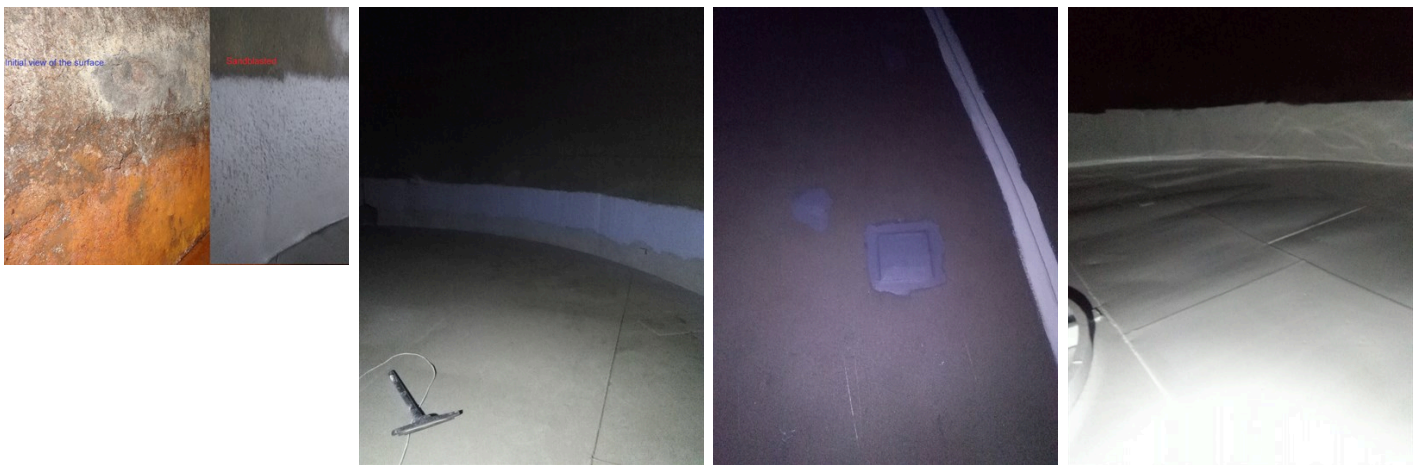
Photograph Descriptions

The tank was suffering from severe internal pitting and corrosion.

- * Initial view of the corroded tank wall ,
- * Wall thickness restoration ,
- * Stripe coating weld seams and plate bonding ,
- * The finished application of Belzona 5892 Corrosion protection ,

Application carried out in accordance with system leaflet TCC-05. The internal walls of the tank were sandblasted before being cleaned and degreased. Belzona 1111 was applied to the severely pitted areas to restore the thickness of the tank wall and metal plates were bonded over larger defect area on the internal floor of the tank. 2 Coats of Belzona 5892 was then applied to tank base and 1m up the side of the internal walls to protect against further corrosion.
