Belzona Repairs a Balcony

ID: 8036

Customer Location: Zagreb, Croatia

Application Date: November 2017

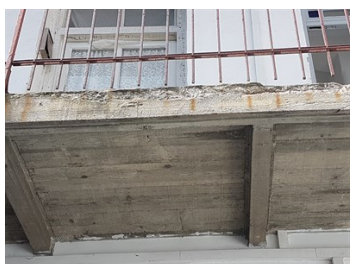
The balconies were repaired 30 years ago. Due to age, carbonation of concrete, exposure to rain/snow and water ingressing into cracks, at the edge of balconies the pieces started to fall down. This was a safety hazard for people walking beneath.

- * 1. Damaged balcony. ,
- * 2. Surface preparation, drying after washing. ,
- * 3. Application completed. ,
- * 4. Application completed (side view). ,

Application was carried out according to FPA-1. Loose parts of the concrete were removed before the surface was cleaned and conditioned. Exposed rebar was thoroughly cleaned and abraded with an MBX Bristle Blaster. The balconies were then resurfaced with Belzona 4111. Cracks were deepened to at least 6 mm, cleaned and filled with Belzona 4111.
