Belzona Repairs a Balcony

ID: 8036

Repair of a 2nd floor apartment balcony in the center of Zagreb.

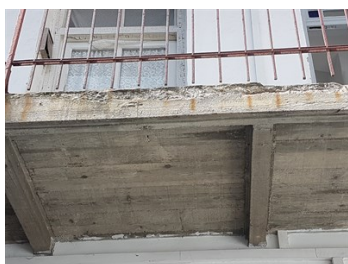
The balconies were repaired 30 years ago. Due to age, carbonation of concrete, exposure to rain/snow and water ingressing into cracks, at the edge of balconies the pieces started to fall down. This was a safety hazard for people walking beneath.

- * 1. Damaged balcony. ,
- * 2. Surface preparation, drying after washing. ,
- * 3. Application completed. ,
- * 4. Application completed (side view). ,

Application was carried out according to FPA-1. Loose parts of the concrete were removed before the surface was cleaned and conditioned. Exposed rebar was thoroughly cleaned and abraded with an MBX Bristle Blaster. The balconies were then resurfaced with Belzona 4111. Cracks were deepened to at least 6 mm, cleaned and filled with Belzona 4111.
