Belzona 7111 Fills the Void

ID: 8044

Industry: *Marine* Customer Location: *Australia*
Application: *GSS-Gaskets, Seals and Shims* Application Date: *May 2019*
Substrate: *Bronze Cutlass Bearing and Aluminium Bearing Housing*
Products: ** Belzona 7111 ,*

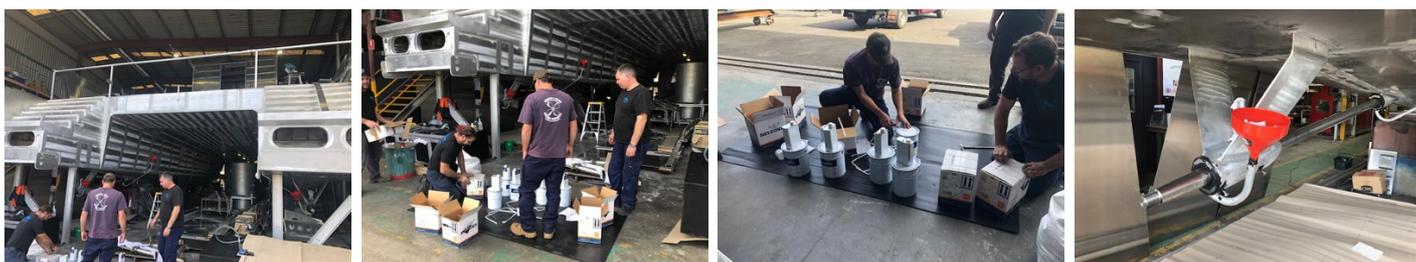
Photograph Descriptions

Cutlass Bearings holding the tail shafts needed to be secured within the housings. This meant a pourable chocking product needed to be used to fill the void between the bearing and the housing.

- * Aluminium new build catamaran ,
- * Application Area ,
- * Preparing Belzona 7111 ,
- * Bearing ready for pouring ,

The product was poured through a funnel and filled the space between the bearing and housing. The excess air was vented out through a vent port.

A modified version of Belzona System Leaflet GSS-13 for precise alignment was used during this application. Belzona 7111 was used as it is a cost effective chocking compound that met the requirements of the customer. As it is 100% solids, it completely filled the gap between the bearing and housing.
