# Belzona Repairs Conductor Casing On Offshore Platform

ID: 8045

Substrate: Wellhead conductor and casing - carbon steel

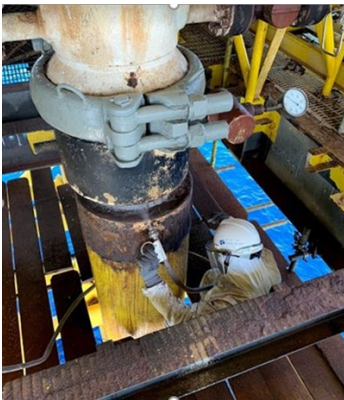
- \* Surface preparation by blasting ,
- \* Pouring Belzona 7111 ,
- \* Sealing with Belzona 3411 ,
- \* Finished Application ,
