# Belzona Cold Plate Bonding Reinforces Offshore Weather Deck

ID: 8046

Customer Location: North Sea - Norway  
Application Date: March 2019

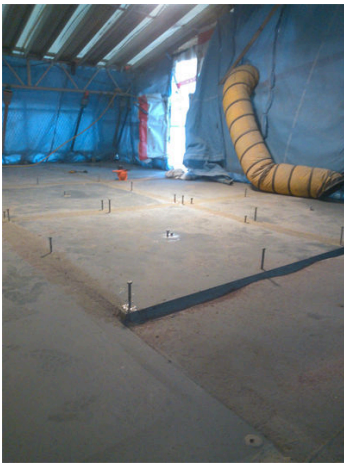
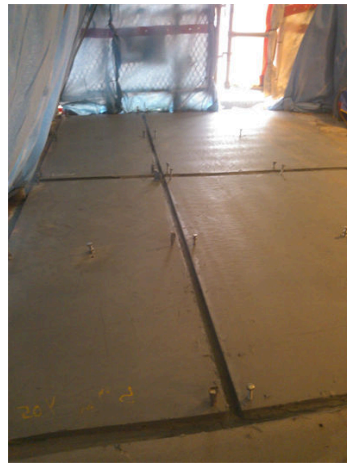
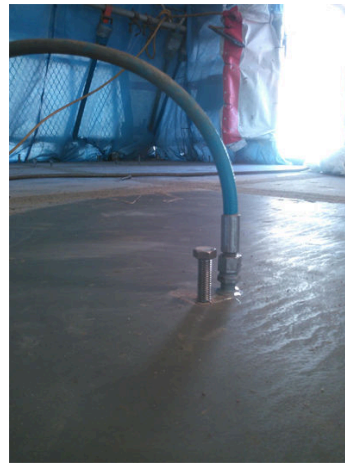
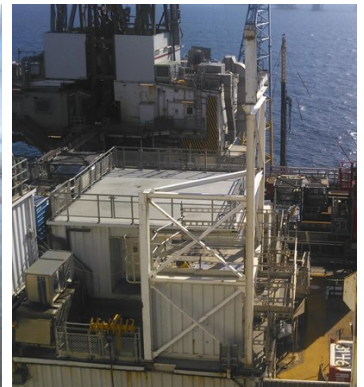
- \* 1. Positioning of Deck Plates. ,
- \* 2. Sealing of deck repair plates with Belzona 1111 (Super Metal) ,
- \* 3. Injecting Belzona 5811 (Immersion Grade) between repair plate and deck. ,
- \* 4. Completed application. ,

The application was carried out in accordance with a Belzona system Leaflet GSS-9 Creating Irregular Shims. All through wall holes on the deck were repaired and sealed with Belzona 1111 (Super Metal) Following gritblasting of manufactured steel plates (various sizes from 1x1metres to 1.6x1.6 metres) and weatherdeck, the plates were positioned and leveled using jacking bolts. The edges of the plates were sealed using Belzona 1111 (Super Metal). Belzona 5811 (Immersion Grade) was injected by single component airless spray into the crevice between the existing deck and reinforcement plate.
