Reconstruction of a concrete tank in the pre-treatment plant using Belzona

ID: 8053

Application: WPA-Wall Problem Areas

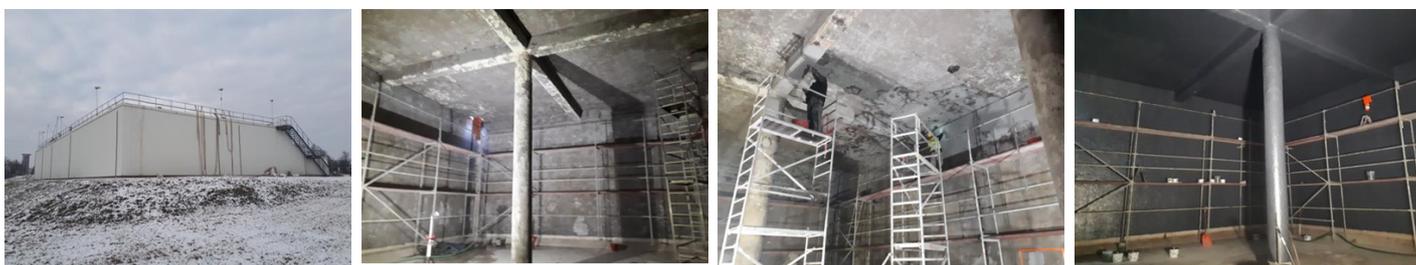
Photograph Descriptions

Destruction of the existing chemical resistant coating and significant losses in the tank ceiling beams. Degradation of the coating by chemically aggressive wastewater and their vapors. Cavities and cracks in the concrete walls and ceiling of the tank. Chemical corrosion of concrete resulting in weakening of floor beams.

- * Treatment Plant ,
- * Treatment Plant Problem ,
- * Treatment Plant Application ,
- * Treatment Plant Complete with Belzona 4111 & Belzona 4311 ,

Reconstruction of defects and chemical protection of the concrete tank in the pre-treatment plant.

The application was completed in accordance with Belzona System Leaflet TCC-15 Thorough cleaning under high pressure, scraping and abrasive blasting of walls and tank ceiling. Conditioning of the deep cavity surface with Belzona 4911 and then repairing with the Belzona 4111
