Chemical Protection of a Sediment Tank

ID: 8054

Industry: *Water / Wastewater*
Application: *TCC-Tanks and Chemical Containment Areas*

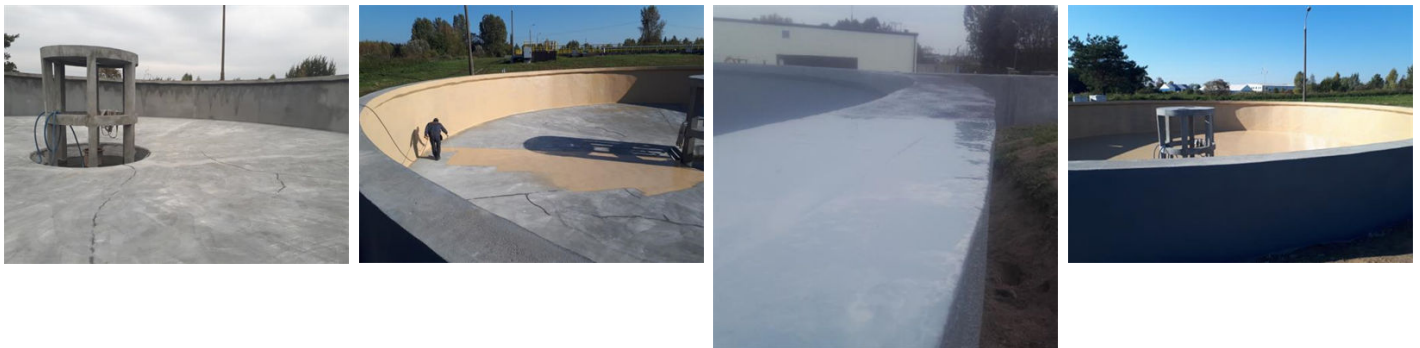
The accumulation of sediment on the bottom and walls of the tank. The penetration of aggressive dirt into the depths of concrete, chemical corrosion of concrete and damage to concrete walls of the tank and cracking at the bottom.

- * Chemical Protection ,
- * Spraying Picture ,
- * Applying Picture ,
- * Application Complete ,

The application was completed in accordance with Belzona System Leaflet TCC-15. High pressure washing, blast-cleaning and vacuum cleaning of the interior of the entire tank. Surface activation and re-profiling of the side wall defects and cracking of the sediment bottom with the Belzona 4111. Applying two layers of the Belzona 5821 coating by airless spraying.
