# Hydroelectric Generating Station Scroll Tunnel

Customer Location: Hydroelectric power station, Alabama, USA

Application: WPA-Wall Problem Areas

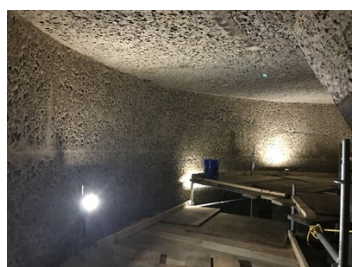
The concrete scroll tunnel walls, floor, and ceiling were deteriorating due to many years of operation. Total area to be treated was 9000 sq. ft. Belzona 4141 lightweight Magma Build was used to restore the ceilings up to 2" thick in areas. The walls and floor were repaired with Belzona 4131 Magma Screed. After restoring the concrete, Belzona 5811 immersion grade barrier coating the was used protect the entire area .

Concrete deterioration

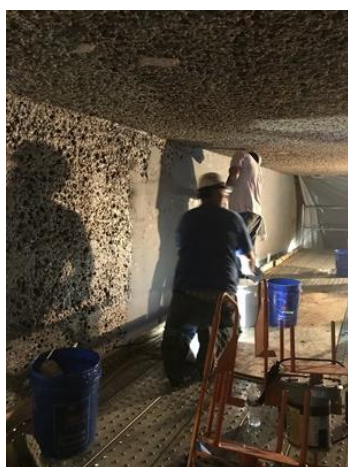
Rebuilding concrete with Belzona 4131

The ceilings were rebuilt with Belzona 4141 following system leaflet WPA-04 and the walls and floor were repaired using Belzona 4131 following system leaflet WPA-04 and FPA-01.

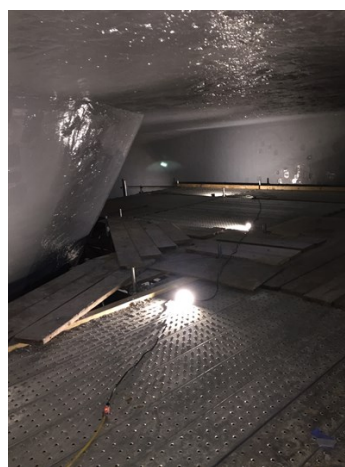
Tunnel coated with Belzona 5811

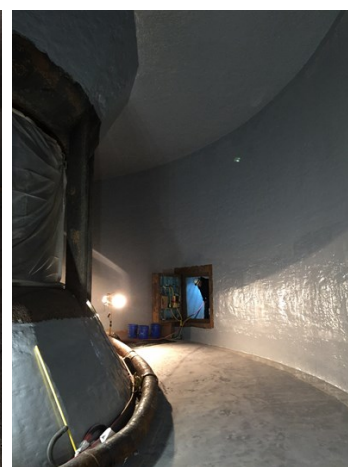
Finished results
