Hydroelectric Generating Station Scroll Tunnel

ID: 8056

Application: WPA-Wall Problem Areas

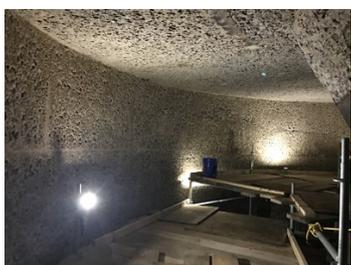
Concrete deterioration

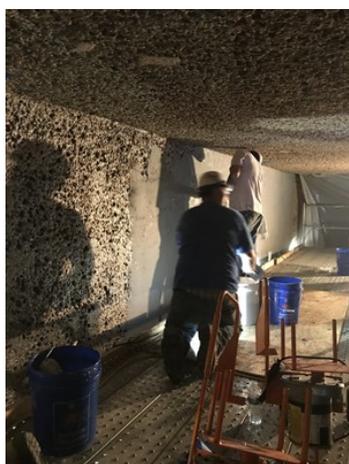
Rebuilding concrete with Belzona 4131

The ceilings were rebuilt with Belzona 4141 following system leaflet WPA-04 and the walls and floor were repaired using Belzona 4131 following system leaflet WPA-04 and FPA-01.

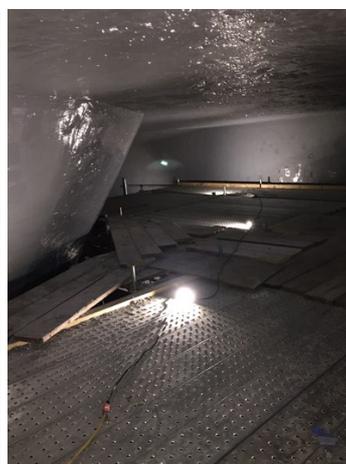
Tunnel coated with Belzona 5811

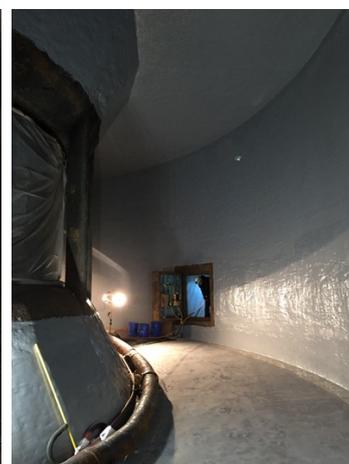
Finished results
