# In-Situ Belzona Shaft Repair at Cement Plant

ID: 8057

Worn cement screw shaft 1 1/2" diameter

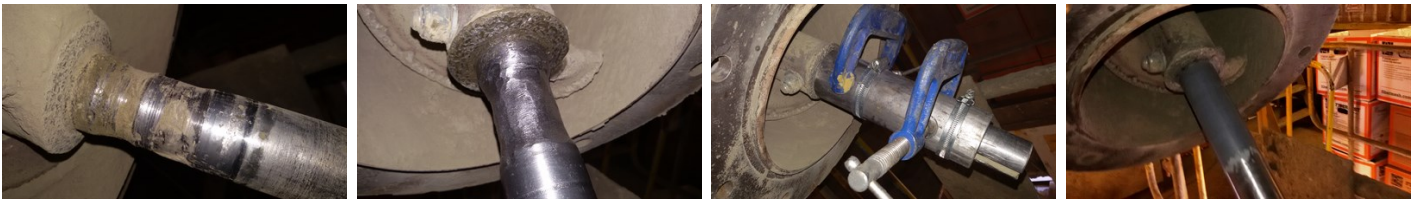
## Photograph Descriptions

Heavy wear of the shaft on the cement screw element had occurred and required repairing before potential equipment failure.

- \* Worn shaft ,
- \* Shaft area prepared for application ,
- \* Former clamped in position after Belzona 1111 application ,
- \* Former removed revealing fully cured Belzona 1111 repair ,

The application was carried out in accordance with Belzona Know-How System Leaflet MPT-2. After thorough surface preparation, the Belzona 1111 was applied by brush to the repair area. A pre-made split former was positioned over the repair area with a clamp. All excess material was removed and the repair was left to fully cure before removal of the former.

2 years on, the shaft is still in service and showing no signs of degradation.
