# Belzona helps in the protection of a surface under the granule scraper.

ID: 8060

Application: *FPA-Floor Problem Areas*

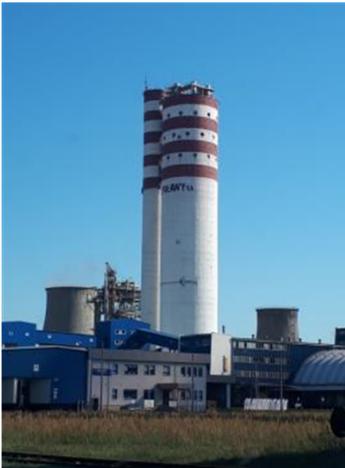
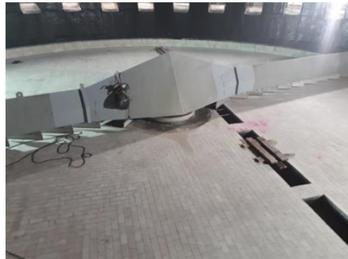
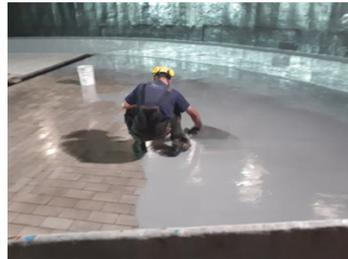
*Corrosion of concrete and surface due to the scraper moving the granules around the area.*

- \* Application Area Picture ,
- \* Area to be treated under the scraper ,
- \* Applying Belzona 4151 & Belzona 5811 ,
- \* Application Completed ,

Repair any surface damaged concrete areas with Belzona 4151 Sealing the surface under the scraper using Belzona 5811.
