# Belzona Chocking Repair on Gear Mounting

ID: 8061

Application: GSS-Gaskets, Seals and Shims

Application Date: 2019

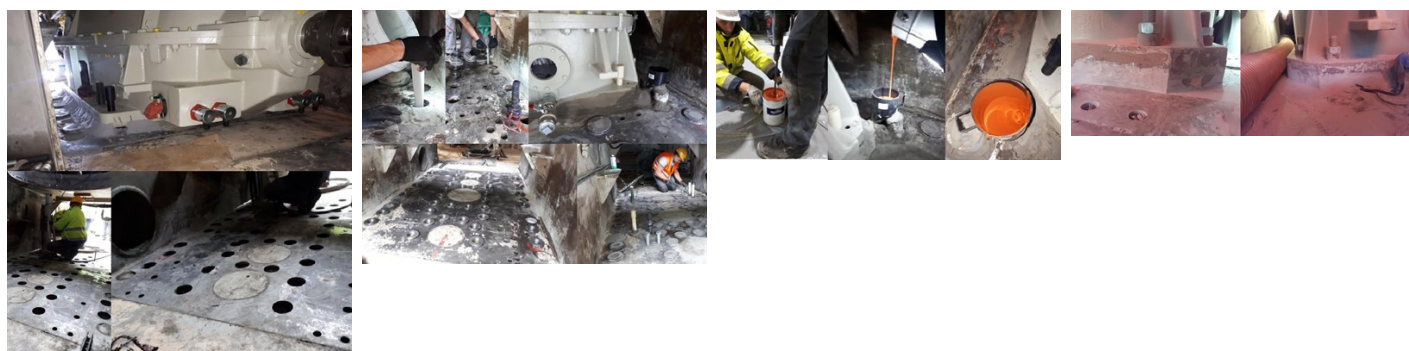
*Gear mounting not working at full efficiency due to misalignment. Repair work need to concrete area prior to chocking.*

- \* 1. Gear Equipment Picture ,
- \* 2. Application of Belzona 4111 ,
- \* 3. Application of Belzona 7111 ,
- \* 4. Chocking application complete. ,

Re-levelling a steel foundation slab of a mill gear and the foundation of the mill on the plate.

The application was carried out in accordance with Belzona System Leaflet GSS-2. Placing of the steel foundation slab using the Belzona 4111. Chocking the foundation of the mill plate using Belzona 7111.
