# Belzona repairs a Metal Expansion Joint

ID: 8063

Customer Location: Israel  
Application Date: June 2019

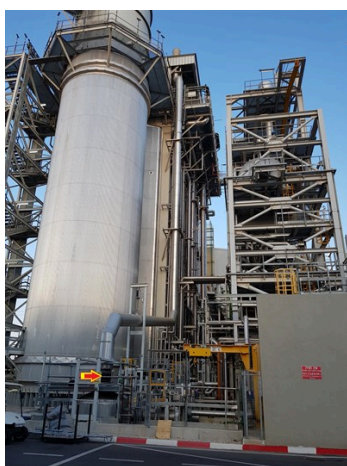
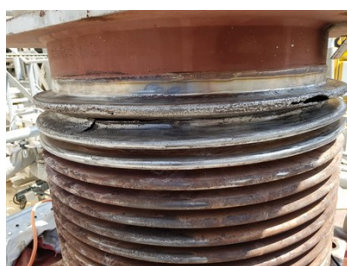
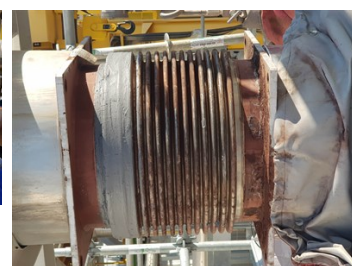
The metal expansion joint that was covered with insulation material deteriorated and have developed major cracks and under insulation corrosion leading to steam leaks in a few spots. As results, the plant had to shut down to stop the leak until replacement joints will be available with very limited ability to shut down in the middle of summer. A fast and effective solution was needed in order to repair the expansion joint as soon as possible.

\* Expansion Joint location Expansion Joint cracks Applying Belzona Material & Reinforcement Tape Finished application ,

The application was similar to VPF-05 system leaflet, but slight variations using Belzona 1000 series material.

The customer main goal was to seal and stop the leak and run the operation as soon as possible due to the high-income losses during the shutdown. The repair was done on the same day and the system was ready for operation about 24 hours later.
