Belzona keeps the hose floating

ID: 8065

Industry: Oil & Gas
Application: SOS-Ships and Offshore Structures

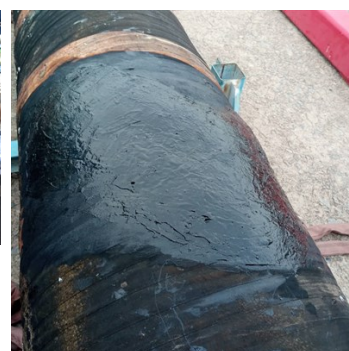
Photograph Descriptions

The offloading hose used to carry petroleum products from offshore to the shore had cuts caused by debris in the sea, contact with passing boats and marine life.

- * Damaged Area ,
- * Surface Preparation ,
- * Degreasing & removing debris ,
- * Completed repair ,

Surface cuts of floating hoses. The hoses have been brought out of the water into a courtyard for repair due to the damage.

Belzona repairs of the floating flexible hose were carried out in accordance with Belzona Know-How System Leaflet SOS – 12. Floating hose surface was prepared using mechanical tools to attain a surface roughness. Belzona 9111 Degreaser/ cleaner was used to clean and removed debris from the substrate surface and left to dry. Belzona 2911 conditioner was applied unto the substrate for bonding and allowed to become touch dry, Belzona 2111 was then applied to rebuild the external cut on the flexible/rubber hose. Belzona 9341- reinforcement Tape was used with Belzona 2111(MP Hi-Build Elastomer)

As the damage to the hose is only on the outer layers, the hose still has structural integrity - therefore the customer wanted to avoid unnecessary replacement, which carries a greater cost and lead time than the Belzona repair. The Belzona repair was carried out and fully cured within 24 hours, allowing the hose to go back into service quickly.
