# Belzona cold repair to a leaking pipe joint

ID: 8066

Industry: Oil & Gas  
Application: VPF-Valves, Pipes and Fittings  
Substrate: Carbon Steel  
Products: \* Belzona 1212 ,  
\* Belzona 9111(Degreaser/Cleaner) ,  
\* Belzona 9341(Reinforcement Tape) ,

Customer Location: Ghana  
Application Date: June 2019

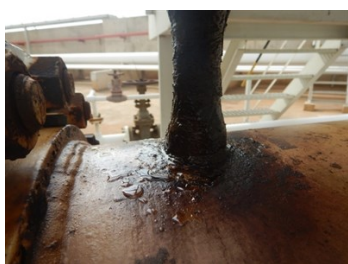
A 1" pipe branching from the 14" main line has a crack and a leak at the joint area. As the line contains flammable fluids hot work is not an option.

- \* Defect area ,
- \* Surface Preparation Complete ,
- \* Application in progress ,
- \* Completed repair ,
