# Belzona Rebuilds and Protects Oil Tank

ID: 8067

Customer Location: Tunisia

Application Date: 2009

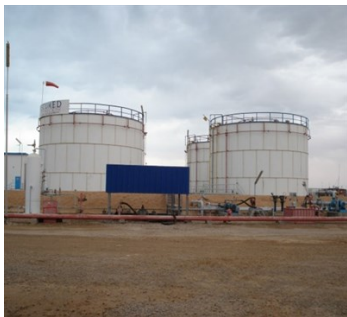
- \* 1. External view of the storage tank ,
- \* 2. Pitting at the base of the tank ,
- \* 3. Belzona 1121 plate bonding ,
- \* 4. Internal coating of Belzona 5811 ,

Crude oil storage tank.

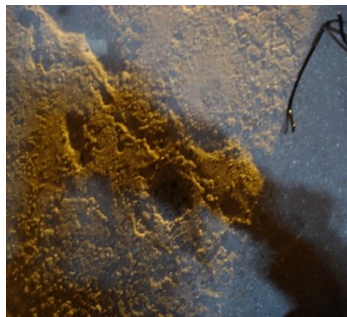
Severe pitting was present at the base and lower section of the tank wall, this was a result of a mixture of water and also hydrocarbons found within the crude oil. As the density of the water is greater than the hydrocarbons, the water will sit at the bottom of the tank causing corrosion in this lower section of the tank.

Belzona 1121 was used to fill in the pits of the localized damaged areas and plate bonding was used to restore any larger damaged areas on the base of the tank. Once the structure of the tank had been restored, 2 coats of Belzona 5811 were applied to the lower section of the tank.
