Belzona seals leak in Wind Turbine Tower

ID: 8068

Industry: Power
Application: TCC-Tanks and Chemical Containment Areas

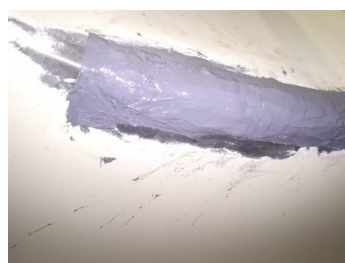
A crack along a weld seam had lead to an oil leak from a bund which is used to contain lubricant oil used for the bearings and gearbox. Loss of containment can cause damage to surrounding equipment and a hazard to personnel climbing the tower.

- * 1. Wind Turbine view from the ground ,
- * 2. View from the top of the tower ,
- * 3. Leak sealed with Belzona 9611 ,
- * 4. Completed repair ,

The application was carried out in accordance with a modified version of Belzone Know-How System Leaflet TCC-1. The surface was thoroughly cleaned, the crack was terminated by drilling holed on each end. The surface was then abraded by mechanical tools before the leak was plugged using Belzona 9611. Once the Belzona 9611 has cured, Belzona 1212 with Belzona 9341 (Reinforcement Sheet) was used to ensure a long lasting repair.
