Belzona seals leak in Wind Turbine Tower

ID: 8068

Industry: Power
Application: TCC-Tanks and Chemical Containment Areas
Substrate: Carbon Steel
Products: * Belzona 9611 ,
* Belzona 1212 ,
* Belzona 9341 ,

Customer Location: Spain
Application Date: May 2019

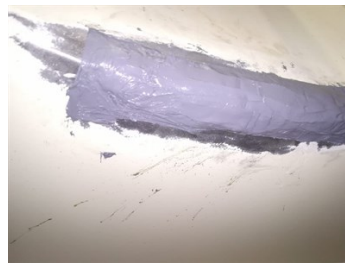
A crack along a weld seam had lead to an oil leak from a bund which is used to contain lubricant oil used for the bearings and gearbox. Loss of containment can cause damage to surrounding equipment and a hazard to personnel climbing the tower.

- * 1.Wind Turbine view from the ground ,
- * 2. View from the top of the tower ,
- * 3. Leak sealed with Belzona 9611 ,
- * 4. Completed repair ,

The application was carried out in accordance with a modified version of Belzone Know-How System Leaflet TCC-1. The surface was thoroughly cleaned, the crack was terminated by drilling holed on each end. The surface was then abraded by mechanical tools before the leak was plugged using Belzona 9611. Once the Belzona 9611 has cured, Belzona 1212 with Belzona 9341 (Reinforcement Sheet) was used to ensure a long lasting repair.
