Belzona Magma Foundations Repair at Cement Factory

Repair of the foundations of the clinker furnace head at a large cement factory in Poland.

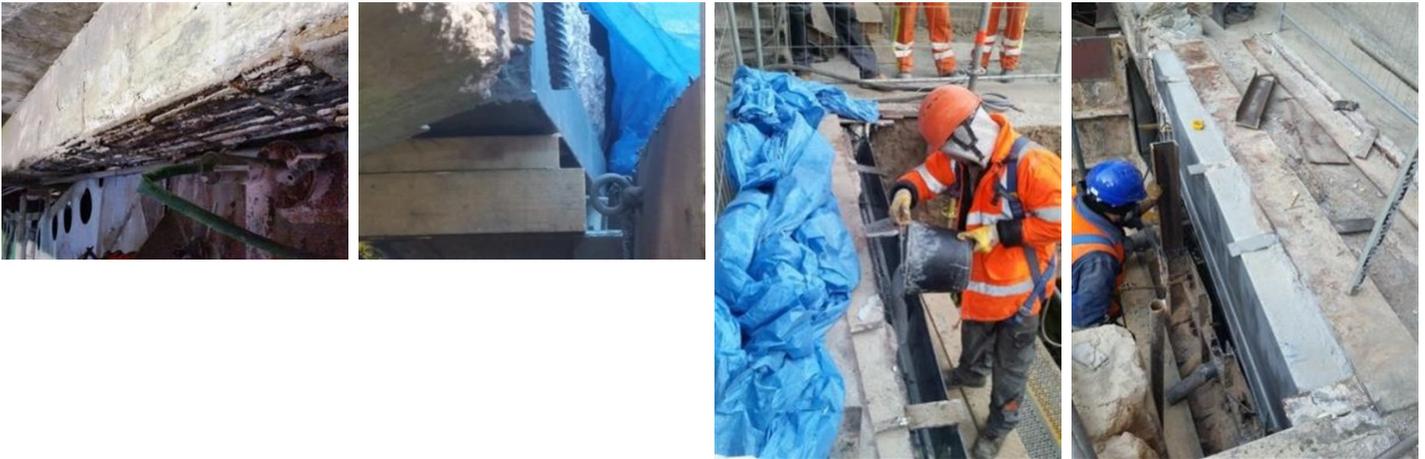
Photograph Descriptions

During long-term operation under varying climatic conditions and high temperatures, the foundation (supports, beams) was degraded under the head of the clinker furnace.

- * Degraded Concrete ,
- * Metal Mould to pour Belzona 4111 ,
- * Applying Belzona 4111 ,
- * Finished Job. ,

The application was completed in accordance with an adapted version of Belzona System Leaflet WPA-4. A metal mould was created around the affected area to pour the Belzona 4111 into to ensure a perfect finish.
