Turbine Restored and Protected with Belzona

ID: 8071

Industry: *Mining & Quarrying*
Application: *FBC-Fans, Blowers and Compressors*

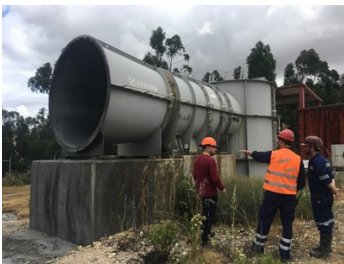
- * 1. Overview of the blower ,
- * 2. Eroded-corrode turbine ,
- * 3. Belzona 1331 being applied to the turbine ,
- * 4. blower back in service ,

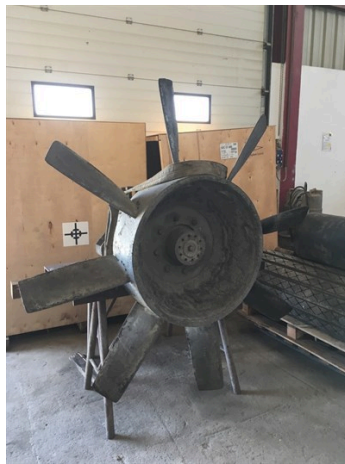
General erosion-corrosion on the turbine of a blower used as part of copper mining process. The erosion had caused a loss of material which could result in balancing issues.

Application carried out in accordance with Belzona Know-How System leaflet FBC-01 & FBC-02. The turbine was grit blasted down to SA 2.5 and then the lost structure was rebuilt with Belzona 1311. Finally 2 coats of Belzona 1331 was applied to prevent further corrosion-erosion.
