# High Temperature Abrasion Protection with Belzona

ID: 8072

Industry: *Steel & Metal Processing*  
Application: *MPT-Mechanical Power Transmission*

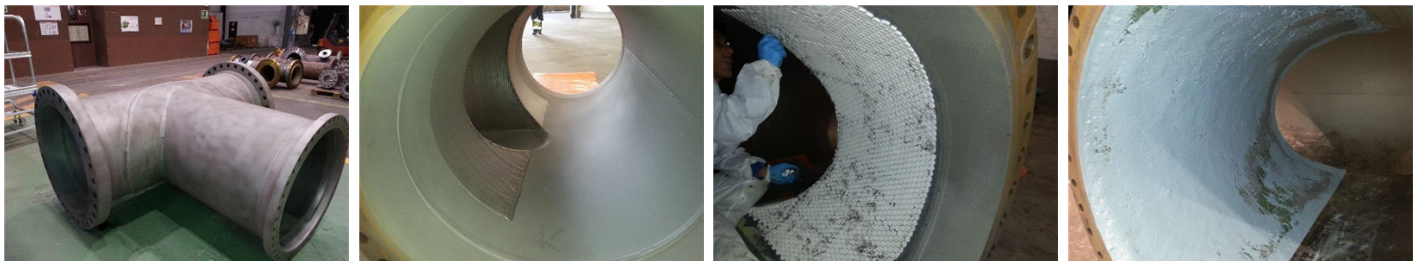
- \* 1. The newly fabricated pipe section ,
- \* 2. Internal surface prepared ,
- \* 3. Belzona 1511 and Belzona 9811 tiles applied ,
- \* 4. Belzona 1813 applied and Belzona 1391T top coat ,

The application was carried out in accordance with a modified version of Belzona Know-How System Leaflet SHM-7. The surface was prepared using grit blasting to the required cleanliness and profile as detailed in the Belzona Instructions for use. Belzona 1511 was applied to the surface and the Belzona 9811 alumina tiles bonded into the material. Belzona 1813 was used to grout between the tiles. A top coat of Belzona 1391T was then applied, to encapsulate the system and give a smooth finish.
