# Corrosion Protection 2 x Industrial Storage Tanks with Belzona 5811

ID: 8073

Industry: Water / Wastewater  
Application: TCC-Tanks and Chemical Containment Areas  
Substrate: Steel  
Products: \* Belzona 5811 (Immersion Grade),

Customer Location: Poland  
Application Date: 2019

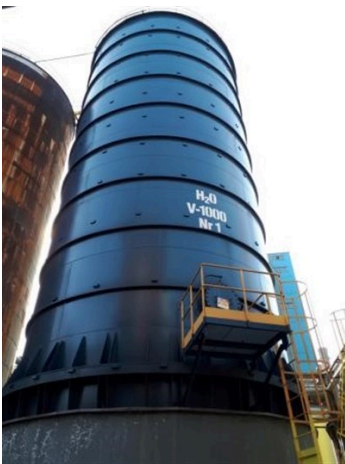
<div>1. One of the storage tanks to be coated.</div>

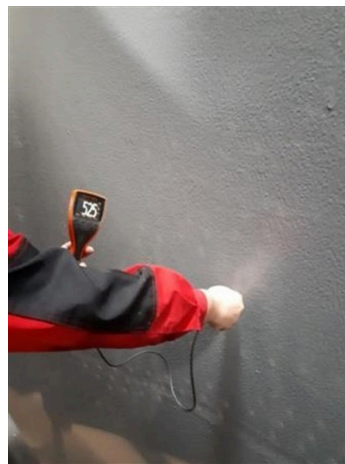
\* 2. Belzona 5811 applied internally. ,

The application of Belzona 5811 was completed in accordance with Belzona System Leaflet TCC-5.
