Corrosion Protection 2 x Industrial Storage Tanks with Belzona 5811

ID: 8073

Corrosion protection for 2 DEMI water tanks (Total area - 1520 m2, 2000m3)

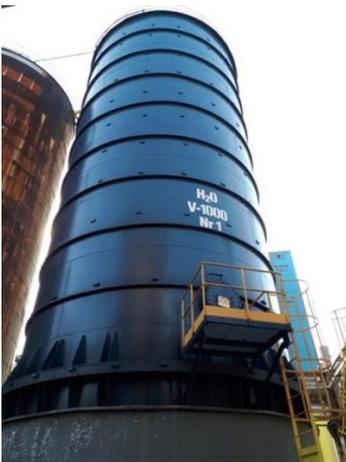
<div>1. One of the storage tanks to be coated.</div>
