# Belzona Ball Mill Trunnion Repair

ID: 8074

Repair of the trunnion section of a grinding mill

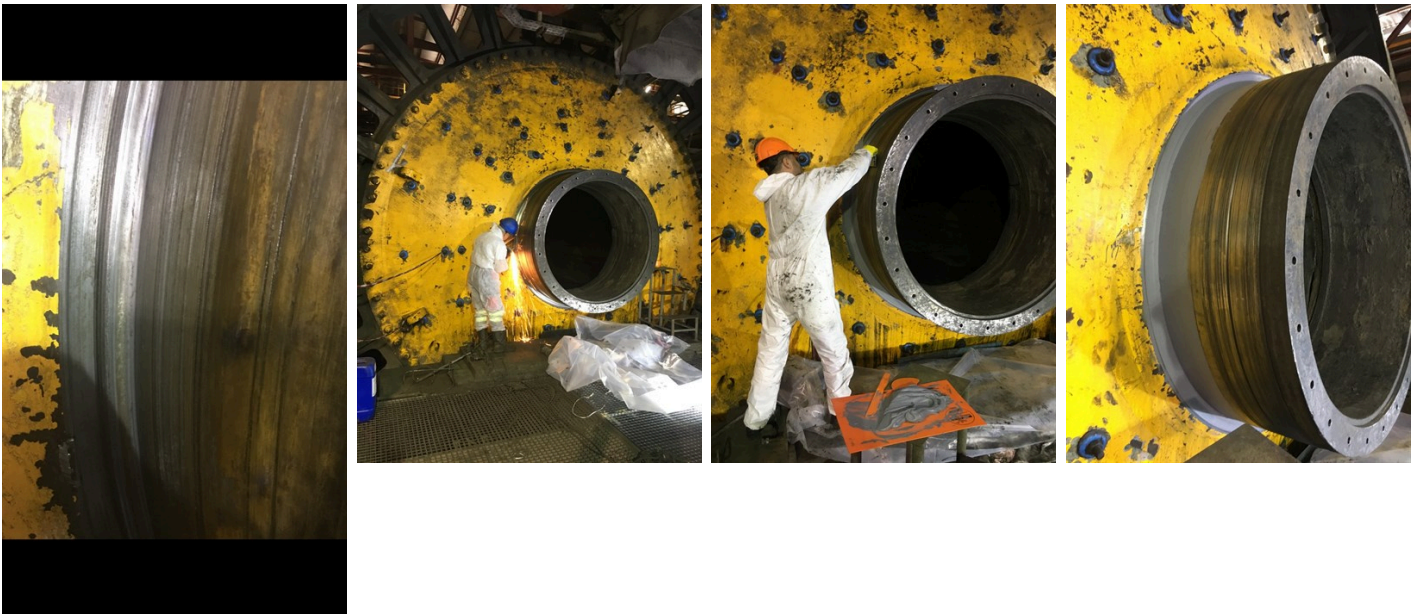
*Wear caused over time by the rotating mill grinding against the trunnion section. Also abrasion from the minerals and ores being ground as part of the mining process.*

- \* 1. Damaged trunnion section ,
- \* 2. Surface preparation using an MBX ,
- \* 3. Applying the Belzona 1121 ,
- \* 4. Final application ,

Application carried out using a modified version of system leaflet MPT-07. An MBX bristle blaster was used to prepare the surface, allowing the paste grade to adhere to the substrate. 17 Kg's of Belzona 1121 was then applied around the circumference of the

trunnion section and smoothed out with an applicator to rebuild the lost materials.
