Belzona secures a lifting winch

ID: 8075

Application: *SHM-Solids Handling Machinery*

Chocking of heavy machinery winch.

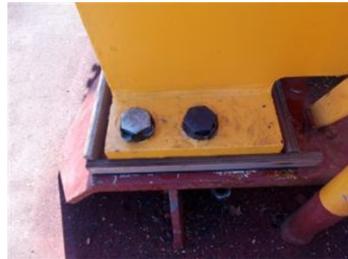
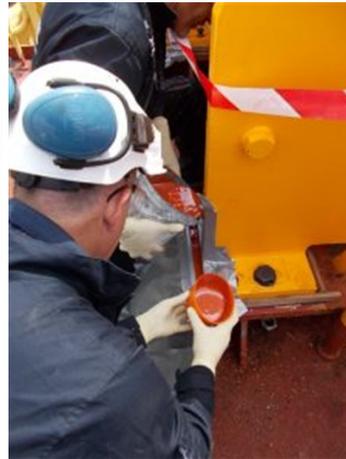
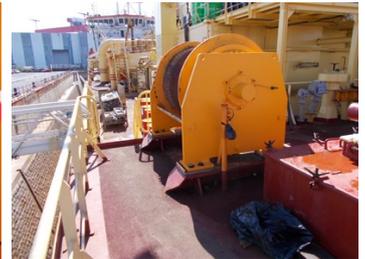
Photograph Descriptions

- * Dredging vessel ,
- * Area marked and dammed, ready for application ,
- * Pouring in progress ,
- * Completed application ,

Lifting winch being secured on the deck of a dredging vessel

The installation was carried in accordance with Belzona System Leaflet GSS-12.

The 4 supporting pads were chocked using Belzona 7111 in order to ensure optimum load transmission as well as long term

protection against vibration. The fast curing properties of the material were a key factor for the operator of the ship.
