Belzona protect new water distribution pipework

ID: 8079

Protection against corrosion / erosion on new sections of pipework

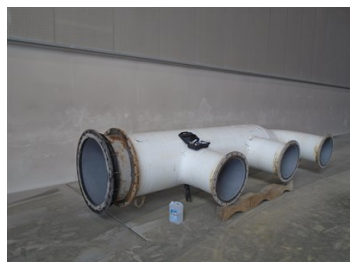
- * 1- Section of pipework (4 in total) ,
- * 2- Application of Belzona 5821 completed ,
- * 3- Inspection in progress ,

New pipework system, 300m² in total (including 4 large pipework sections, 52 bends and 5 tees)

Hand application of Belzona 5821 followed by a thorough inspection to ensure that the application was carried out as per the Instructions For Use.
